DEPARTMENT OF THE NAVY
NAVAL SURFACE WARFARE CENTER
CARDEROCK DIVISION

The attached diagram shows the optimum location for the Rhino Horn. The estimated optimum location is approximately 4 feet more inboard than what LSI is building to. Note on the diagram that LSI's horn location, 8 ft from tip of module, is very near the waterline. During the transition of cargo, the fwd end of both the lighter and the sea section will submerge and thereby increase the draft waterline. At this point, the Rhino horn (at LSI's location) may even be partly under water. Locating the Rhino horn up higher is better in terms of trim during cargo transfer. However, the lighter would have to get closer to the fwd end of beach/sea ramp - see next paragraph..

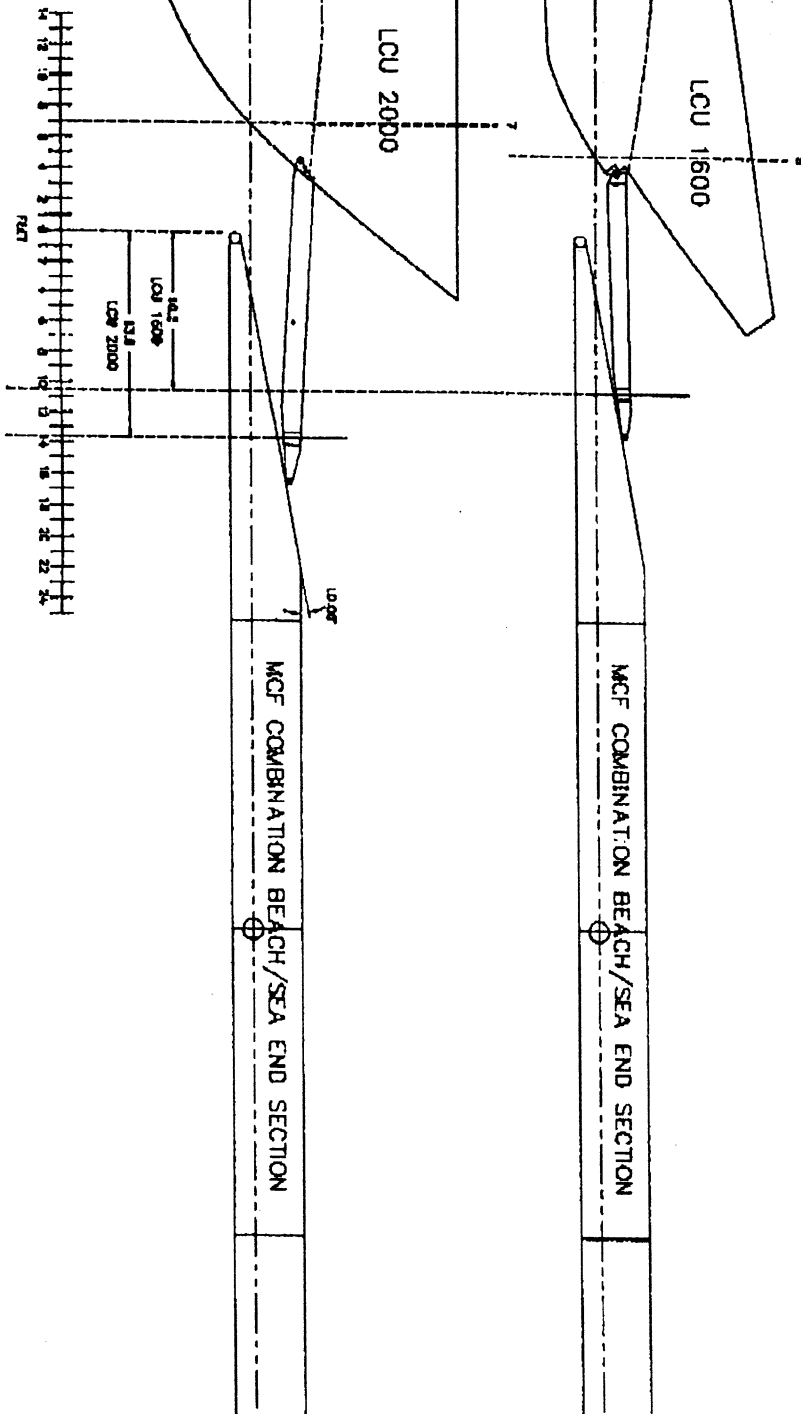
Note the proximity of the lighter bow hull to the sea end section. A fender should be installed on the tip of sea end section to prevent any possible damage. I will volunteer to design a fendering system for this application. Please call me to discuss.

APPROXIMATE RHINO HORN LOCATION
ESTIMATED SEPARATELY FOR EACH VESSEL

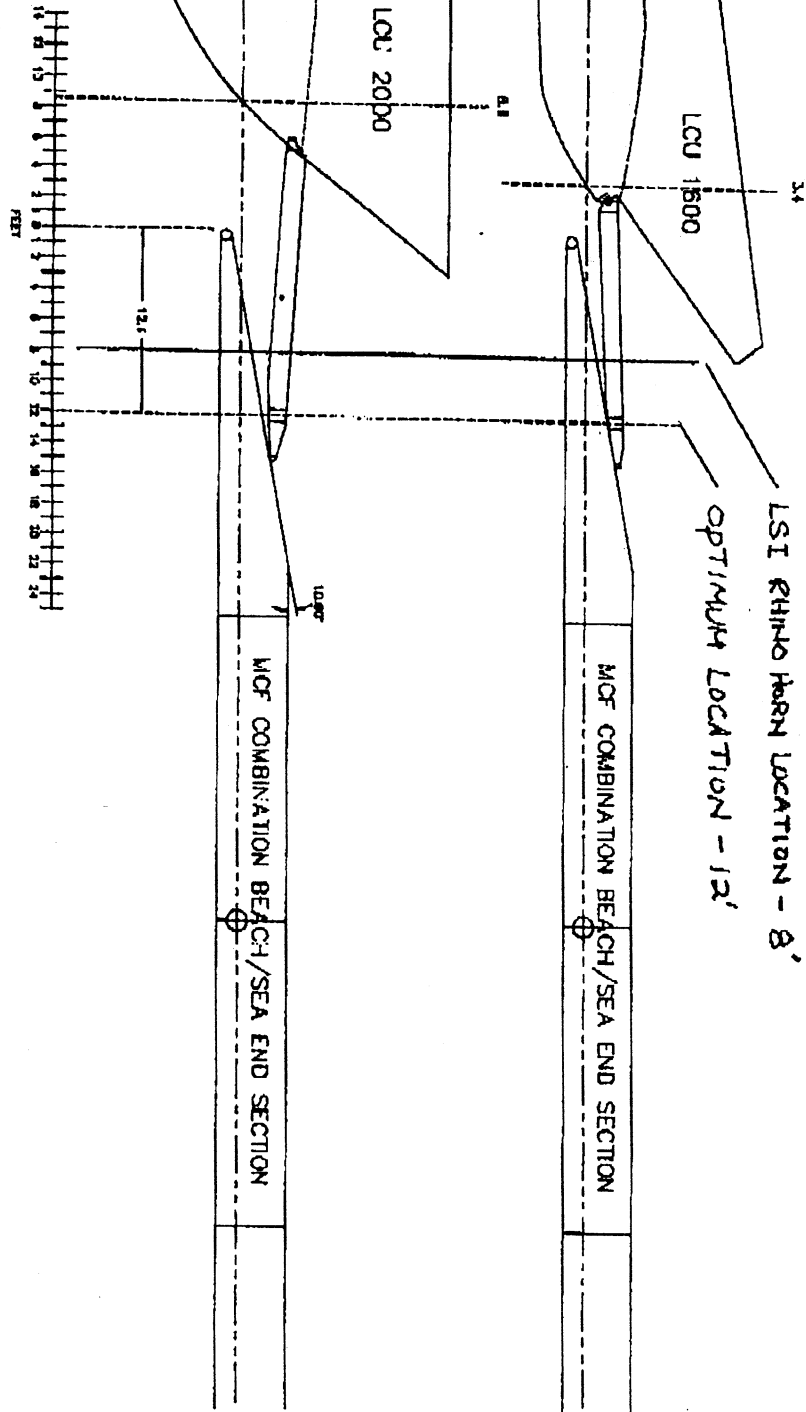
APPROXIMATE COMPROMISED RHINO HORN LOCATION

It may be smart for us to consider requesting LSI to change the location of the Rhino Horn before its too late.
